Report on Evaluation of
Thin Hot Mix Asphalt Overlays
and
SR 164 Case Study

Thomas R. Tate, P.E.
Trenton M. Clark, P.E.
VDOT Materials Division
Pavement Design and Evaluation Section

July 30, 2004

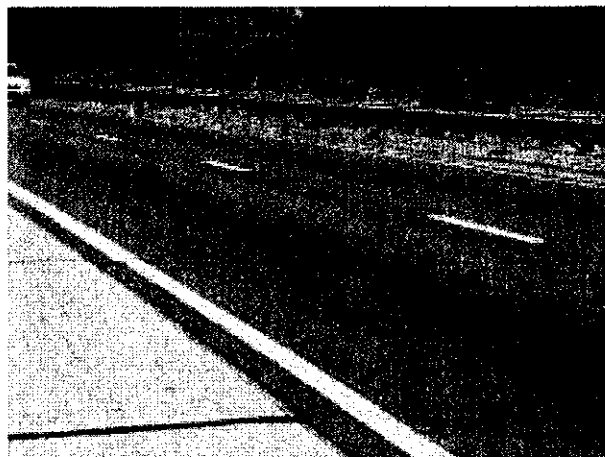
Photograph No. 1: Reflective crack (I 440 in Raleigh).

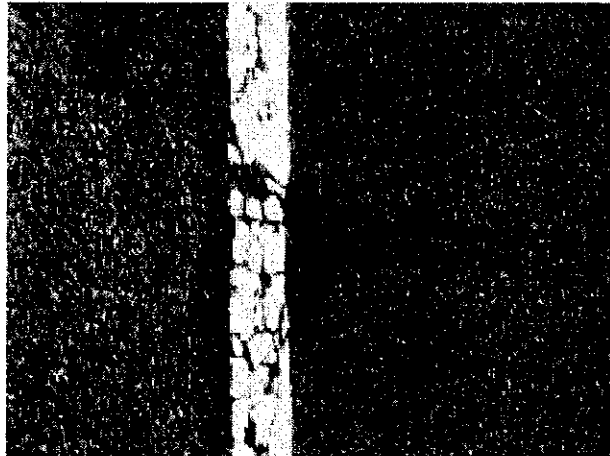
Photograph No. 2: Reflective crack seeping water (US 1 in Cary).

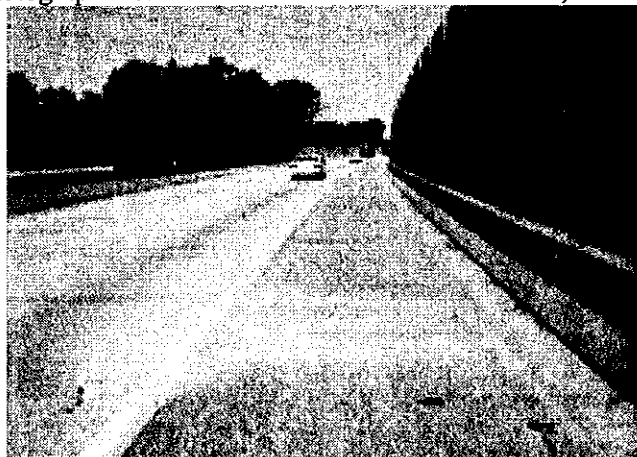
Photograph No. 6: Fines on shoulder near punchout shown in Photograph No. 5.

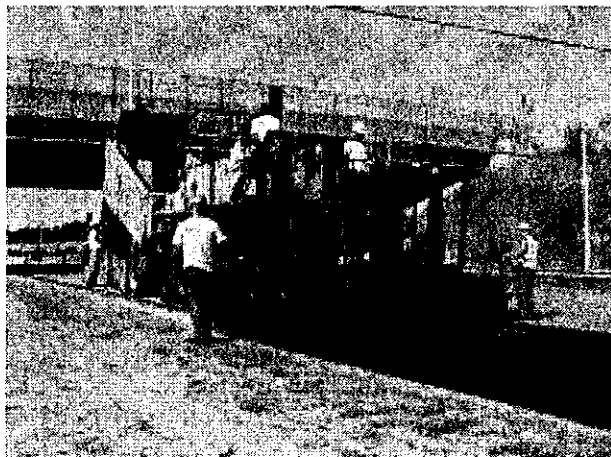
Photograph No. 7: Application of THMACO on SR 164, October 2003 (MP 2.34, WBL).

In July 2003, a contract for installing edge drains, sealing pavement joints, patching CRCP failures, and construction of a thin hot mix asphalt concrete overlay (THMACO) was awarded. After completion of this work in the Fall of 2003, non-destructive testing (NDT) of the pavement was performed. Non-destructive testing performed included FWD, skid, roughness, and visual surveys. The NDT data obtained was compared to previous data where available. The following sections present a comparison of data obtained before the pavement rehabilitation and after.
