Project Profile

Project Location: US 27 Lansing, Michigan
Date Placed: August 12, 2002
Traffic: 1870 ADT, 12.5% trucks
 Approx. 2.8 million 20-yr ESALs

Strata® Section

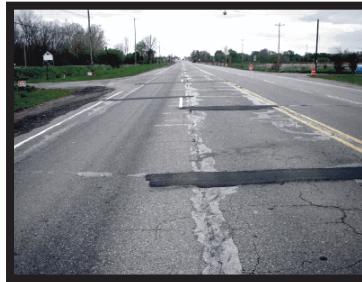
Previous Condition: PCC with variable depth HMA overlay; cracks full width of pavement

Pre-Project Surface

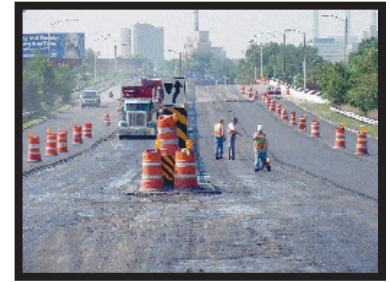
Interlayer Construction Over Milled Surface

Interlayer thickness: 1"
Overlay mix type: MI 5E3-H (nominal maximum 3/8")
Overlay Thickness: 2.5"
Overlay PG used: PG 70-28

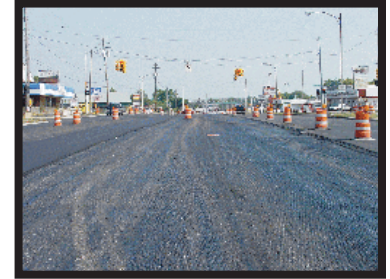
Project Layout

The Strata® section was in the passing lane, while the control section without the Strata® interlayer was in the driving lane.

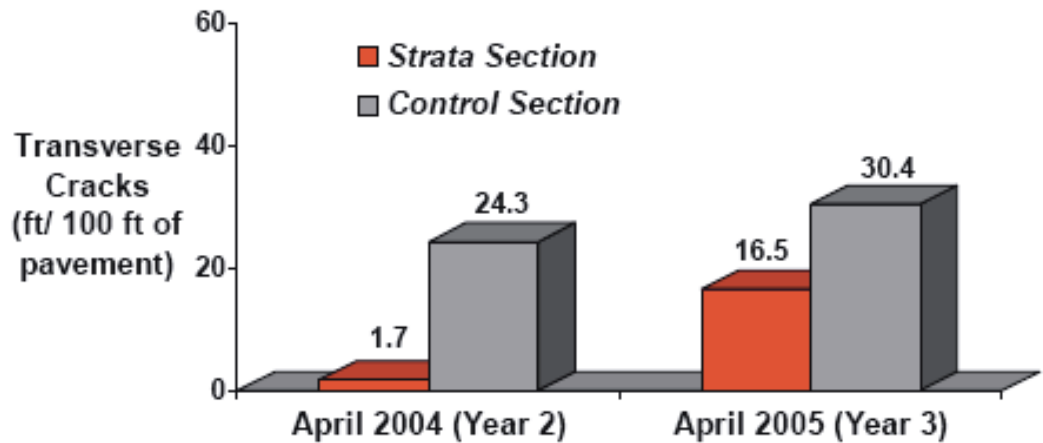
Crack counts were performed in April 2004 and April 2005. The data represents the average lineal feet of cracking per 100 ft section of pavement. The graph shows the reflective cracking in the control section is significantly higher than in the Strata® section, and the photo shows a typical crack in the control section stopping at the Strata® section.
