# Project Profile

**Project Location:** SH 3, Texas City, Galveston County, TX  
**Date Placed:** February 2002  
**Traffic:** 3 million ESALs; 12,000 ADT

## Strata® Section

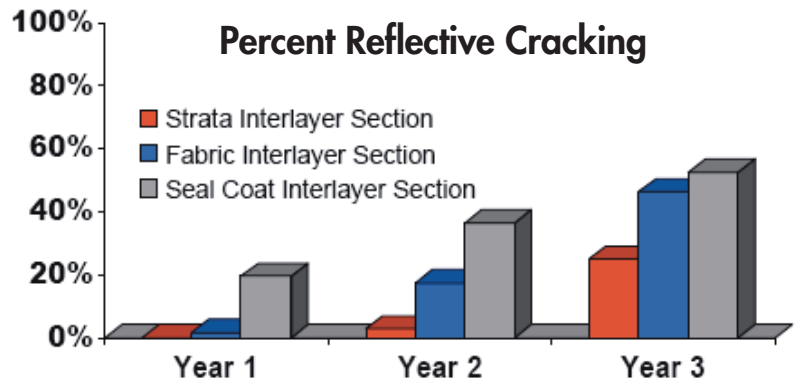
Performance evaluations were made after one, two and three years. The graph shows the percent of preexisting cracks that have reflected through the new surface.
