NCAT Report 97-05

CONSTRUCTION AND PERFORMANCE OF ULTRATHIN ASPHALT FRICTION COURSE

September 1997

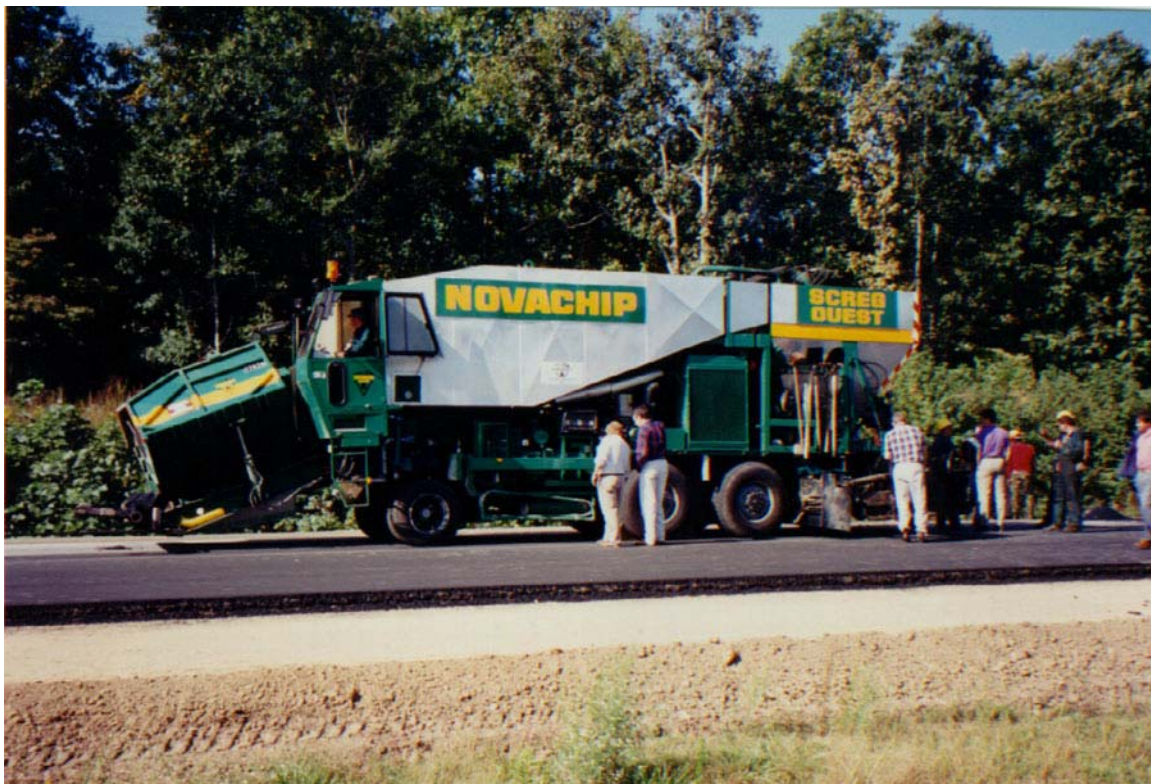
Figure 2. Novachip Paving Machine Used in Alabama

Novachip paving equipment (Figure 2) was imported from France. Primary operating personnel also came from France to demonstrate the equipment and place the test section. Figure 2 shows

the receiving hopper at the left end of the machine, and tack coat spraying mechanism at the right end of the Novachip equipment.

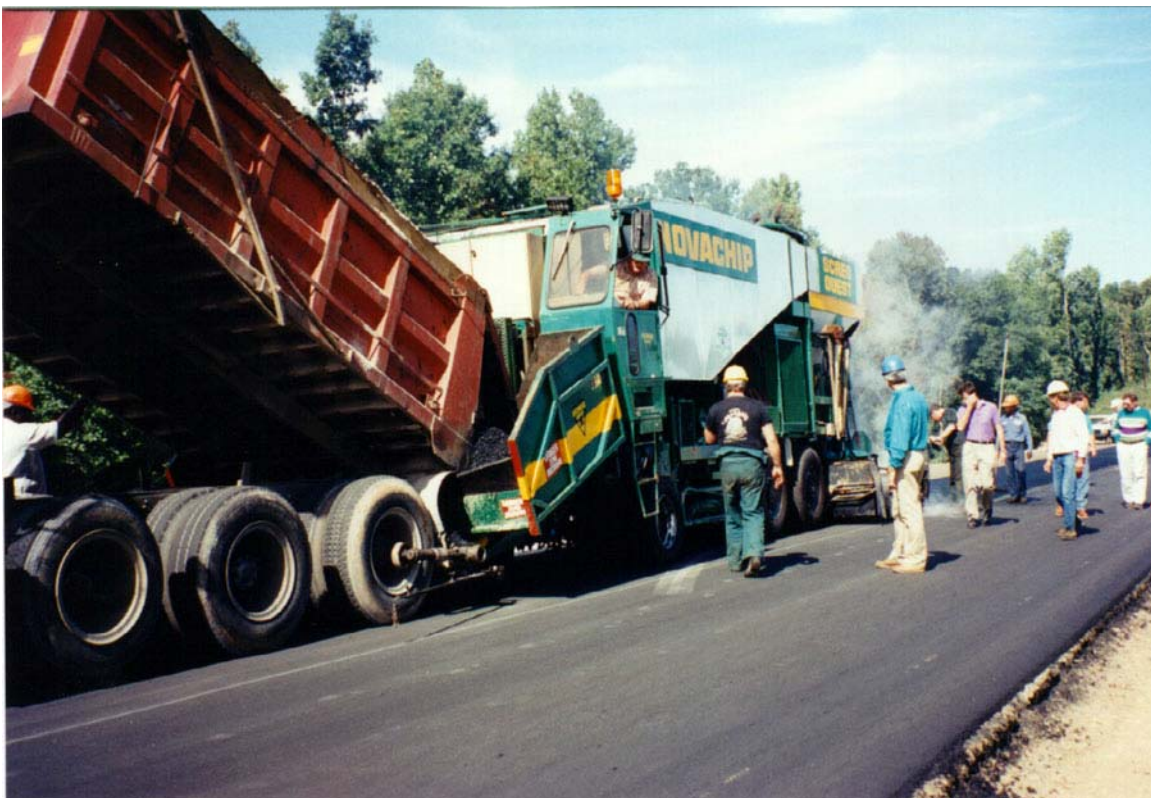
Figure 3. Truck Discharging Mix into Hopper

Novachip paving on this project was accomplished on October 1-2, 1992. The granite Novachip was placed on October 1 followed by the gravel Novachip on October 2. The ambient temperature ranged from 14 to 27°C (58 to 80°F). The machine traveled at a rate of 24-27 m (80-90 feet) per minute. Figure 3 shows a truck discharging mix into the hopper of Novachip machine. The Novachip surface after rolling appeared similar to an open-graded friction course (OGFC). Average rate of the Novachip mix used was 30 kg/m² (55 lbs./sq. yd). The following observations were made during the construction.

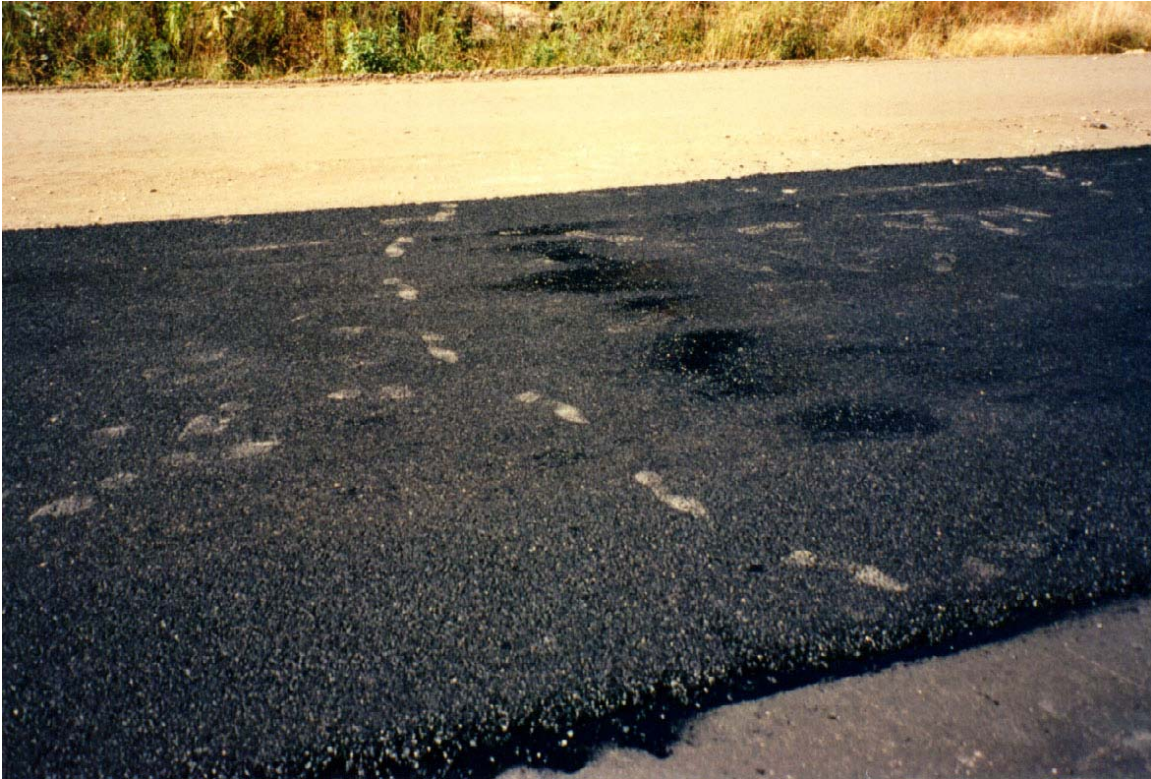
1. The emulsion spray bar, pumping, and storage system created significant problems during the test section construction. The spray bar did not have positive closure at each spray nozzle. Whenever the emulsion distribution system was shut off, the material remaining in the spray bar drained (leaked) onto the pavement, creating a large puddle of excess emulsion (Figure 4). In some locations where this situation occurred, excess emulsion was visible on the surface of the finished pavement. In addition, the system's emulsion storage tank did not have provisions for heating the emulsion. Therefore, maintaining the desired temperature of the tack coat was dependent on the Novachip paver's insulated tank's efficiency. These factors, in conjunction with the opening size of spray bar nozzles, and the equipment's speed of travel had an influence on the varying rates of tack coat application.

Figure 4. Tack Coat Puddles Where the Machine Stopped

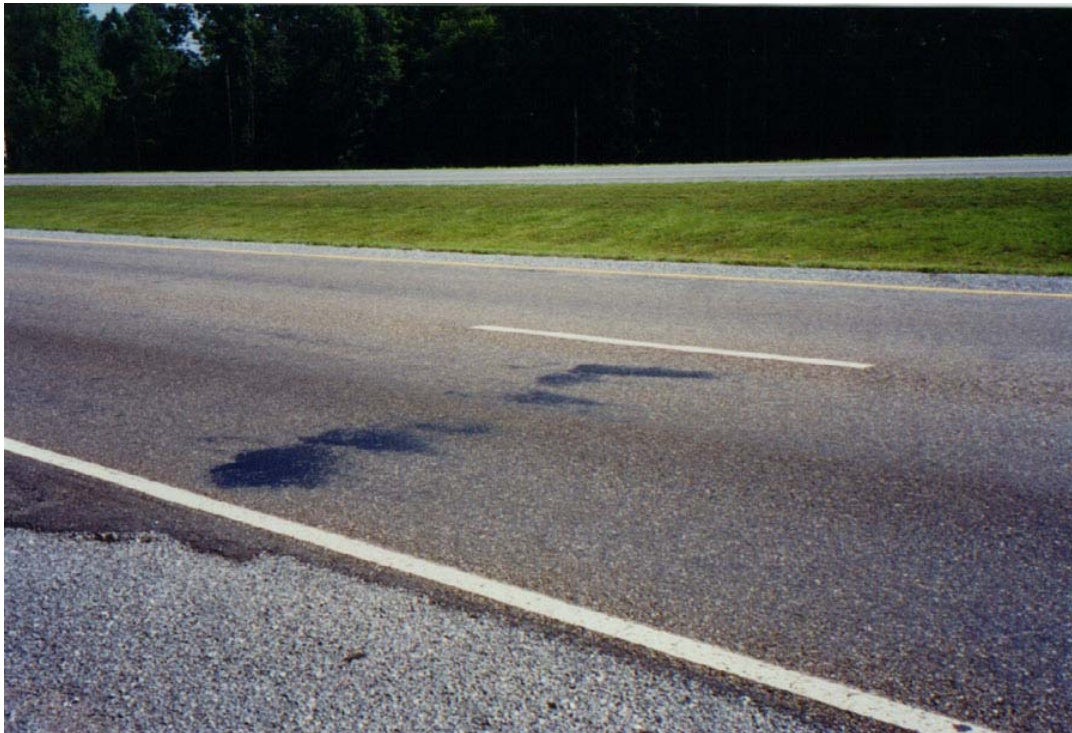
The 1996 average daily traffic (AADT) on this road is 13,044 with 10-1/2% trucks. No significant loss of Novachip or raveling has taken place in both granite and gravel test sections. This indicates very good adhesion between the Novachip and the underlying surface. As reported earlier, excessive emulsion tack coat puddles had resulted during construction from the leakage of spray bar wherever the machine stopped during paving. The excess emulsion was visible on the surface of the pavement within a year, and it was still evident after 3-3/4 years (Figure 5). This leakage problem was later rectified.

Figure 5. Tallapoosa Project - Flushing Due to Spray Bar Leakage

1. Spotty flushing of emulsion tack coat through the Novachip mix was caused from equipment related problems. The nozzles in the spray bar did not have a positive shut off and leaked when the machine stopped.
2. The amount of tack coat should be lower in a travel lane as compared to a passing lane to minimize flushing in the wheel tracks of the travel lane.
3. The surface texture of Novachip is very similar to that of a typical open-graded friction course.
4. No significant raveling was observed on these two projects after about 3-3/4 years,

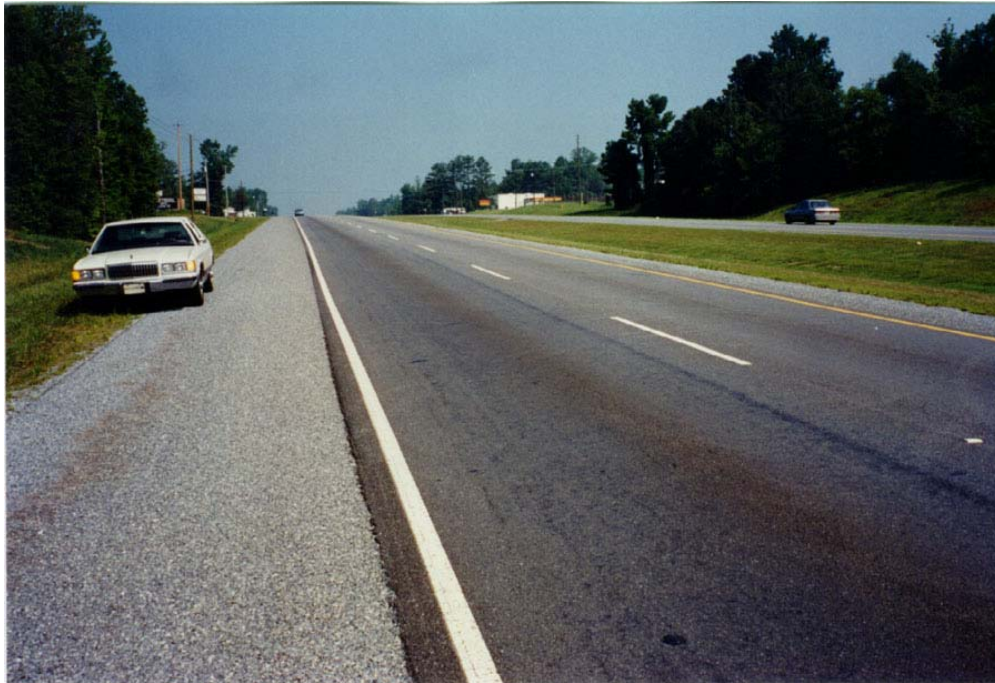
The granite section which was placed first shows moderate flushing in the wheel tracks of eastbound travel lane and slight flushing in the wheel tracks of the eastbound passing lane as shown in Figure 6. The gravel section which was placed on the following day shows slight flushing in the wheel tracks of the traffic lane and no flushing in the wheel tracks of the passing lane as shown in Figure 7. It is possible that the tack coat application rate was reduced and was just adequate for the gravel section. It appears that in future work the application rate should be maintained lower for the traffic lane compared to that for the passing lane. It was observed in both granite and gravel sections that worn aggregate was visible at the surface and was not covered by flushed asphalt binder. Therefore, frictional resistance of the flushed areas should not be adversely affected much.

Figure 6. Tallapoosa Project - Granite Section Showing Moderate Flushing in Travel Lane (Left) and Slight Flushing in Passing Lane (Right)

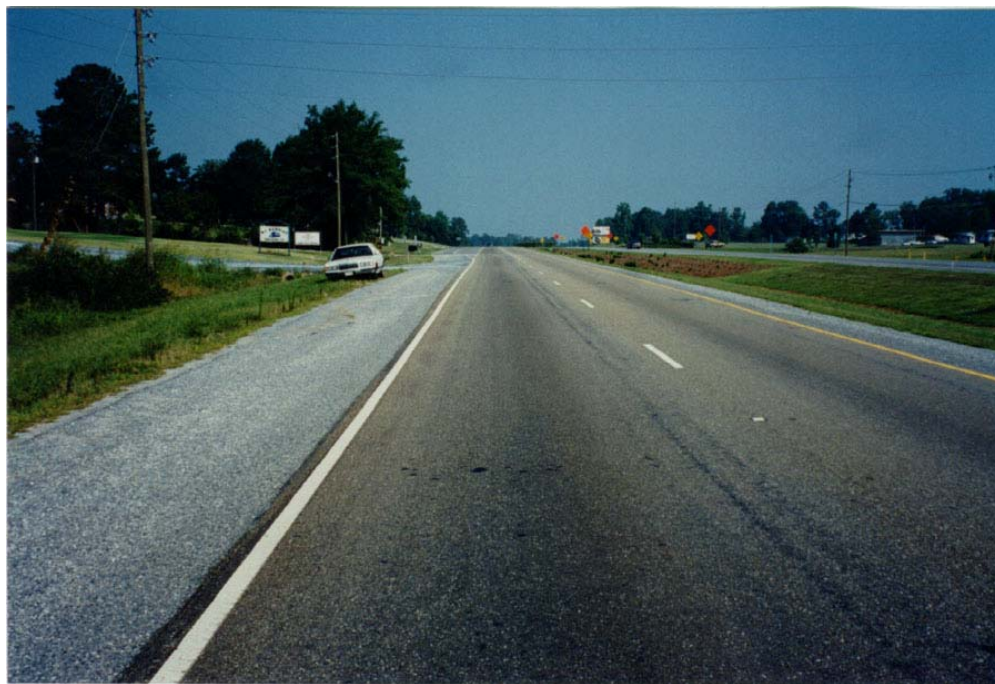
Figure 7. Tallapoosa Project - Gravel Section Showing Slight Flushing in Travel Lane (Left) and no Flushing in Passing Lane (Right)

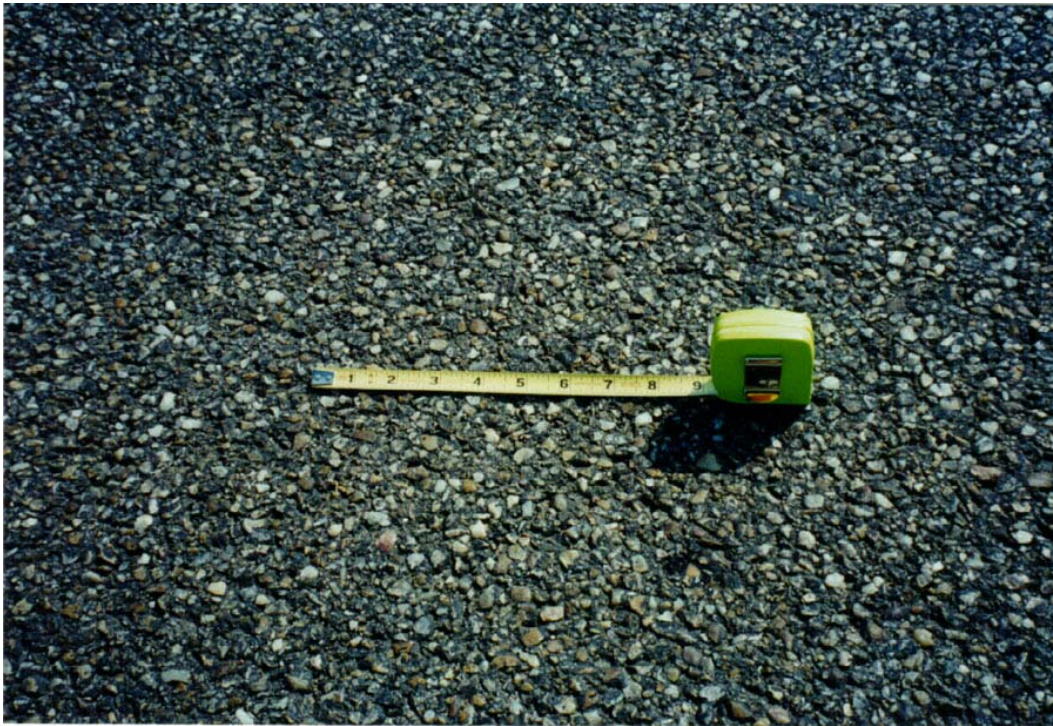
Figure 8 shows a close-up of gravel Novachip surface which appears like the surface of a typical open-graded friction course (OGFC). Figure 9 shows a comparatively dense surface of the control section which used dense-graded wearing course mix (AL Designation 416) consisting of granite aggregate.

Figure 8. Tallapoosa Project - Closeup of Gravel Novachip Surface After 3-3/4 Years

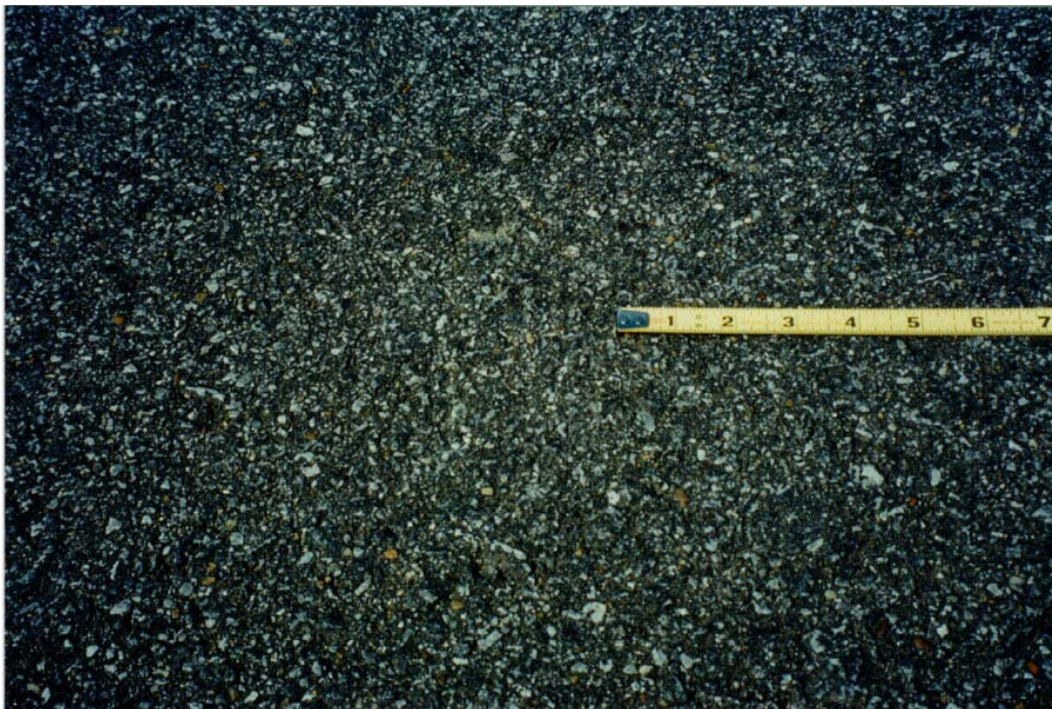
Figure 9. Tallapoosa Project - Closeup of Dense-Graded Wearing Course Mix After 3-3/4 Years

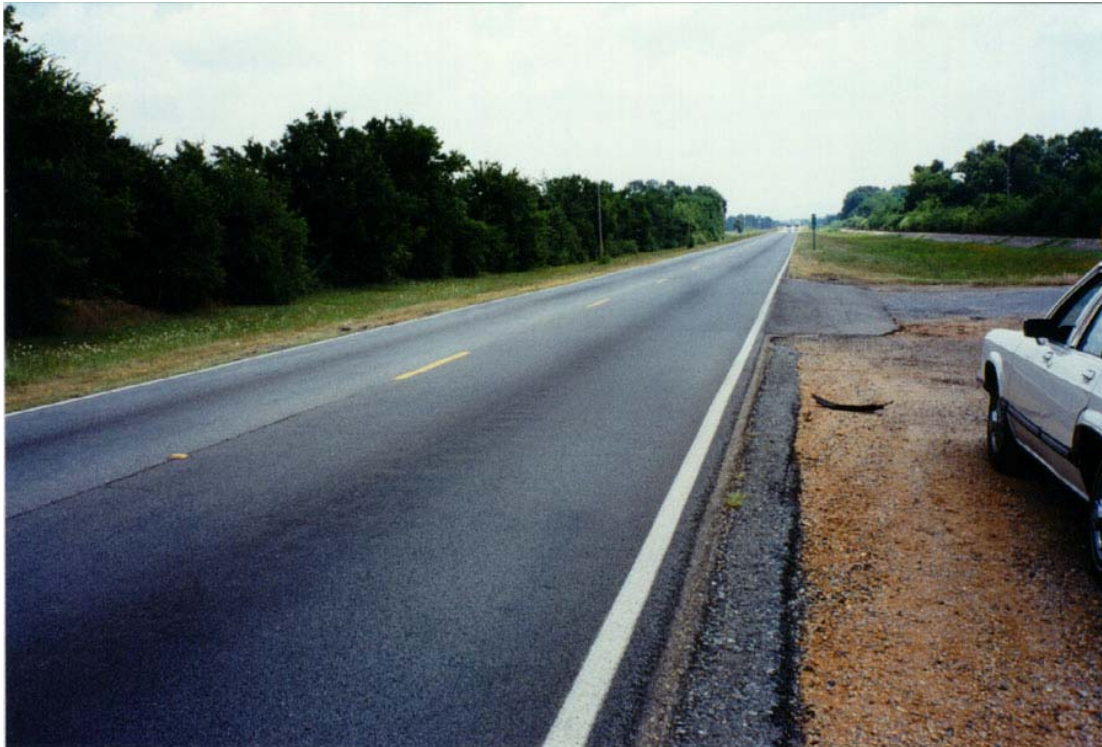
The 1996 average daily traffic (AADT) on this road is 7,534 with 11-1/2% trucks. This project also does not show any loss of Novachip or raveling after about 3-3/4 years' service. Some transverse cracks have reflected through the Novachip surface. The puddles of excessive tack coat are minimal on this project compared to Tallapoosa project. After the Tallapoosa project, the machine had been to Mississippi and Texas before this project was started. Obviously, the tack coat spray bar was repaired. This project does show some excessive tack coat bleed through the Novachip mix in wheel tracks and scattered areas at some places. This two-lane highway has a high crown and uneven surface. It appears that tack coat puddles in the wheel tracks and scattered depressions have caused the flushing problem. Obviously, Novachip cannot effectively remove large surface irregularities. It is also possible that the existing surface was non-uniform in surface texture and, therefore, absorbed the emulsion tack coat to different degrees. However, the Novachip surface is reasonably uniform and generally acceptable on this project (Figure 10). Even in scattered flushed areas, the worn granite aggregate is visible at the surface and, therefore, slight flushing should not adversely affect the surface friction. The surface appears much more uniform after 3-3/4 years' service compared to the surface just after construction.

Figure 10. Talladega Project - General Uniform Appearance of Novachip Surface
